National Register of Historic Places  
Registration Form

historic name St. Mary's Church (Roman Catholic) Historic District

street & number South Main Street bounded by U.S. Rt. 46 and St. Mary's Street  not for publication

city or town Borough of Wharton  vicinity

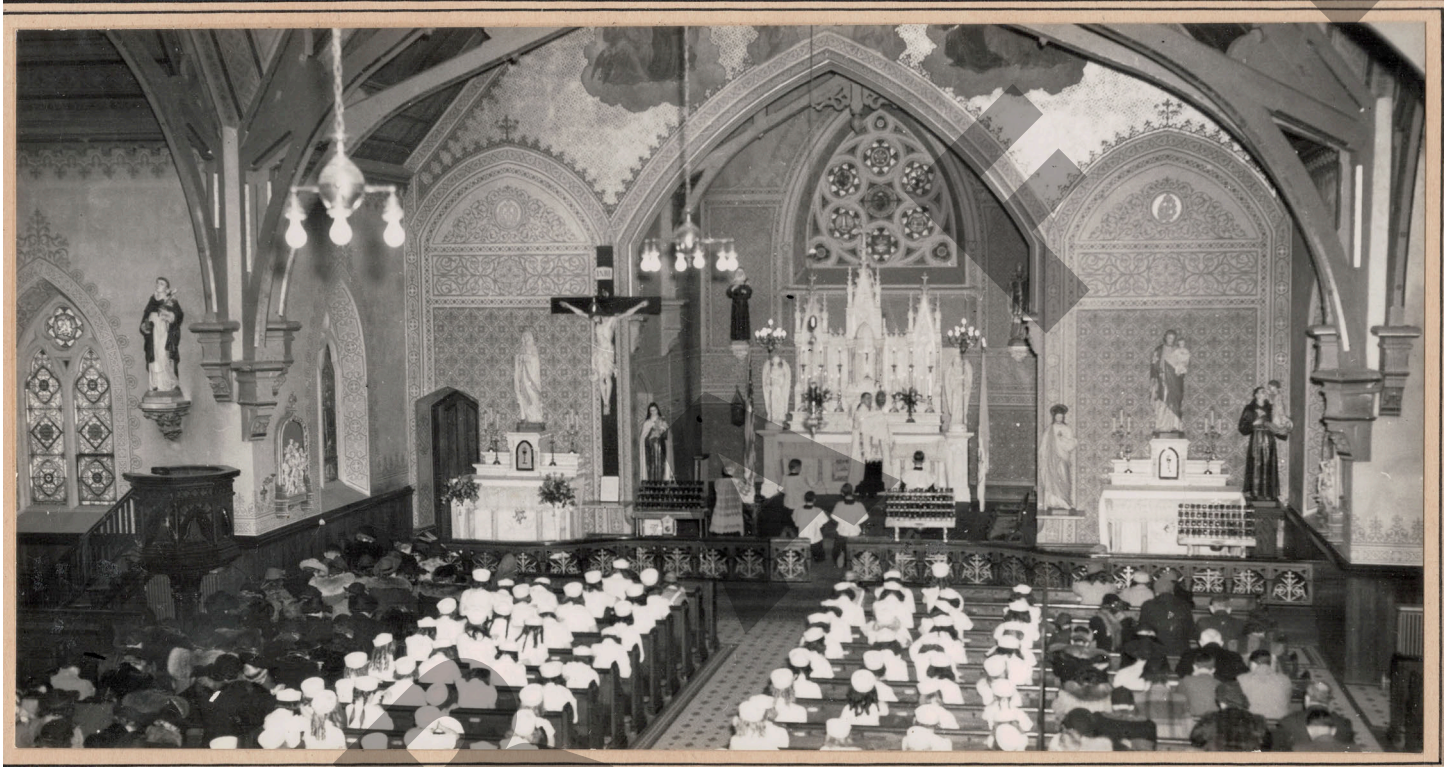
12. Church interior, 1945. Shows the interior as it generally appeared after the 1908 renovation by the O'Rourke firm and until the early 1960s, with minor decorative changes also occurring in the 1950s. Archives of St. Mary's Church
